AVS SERVICE INSTRUCTIONS

STEP TYPE	KM	Last Updated	9/7/06
VEHICLE TYPE		Revision no:	1

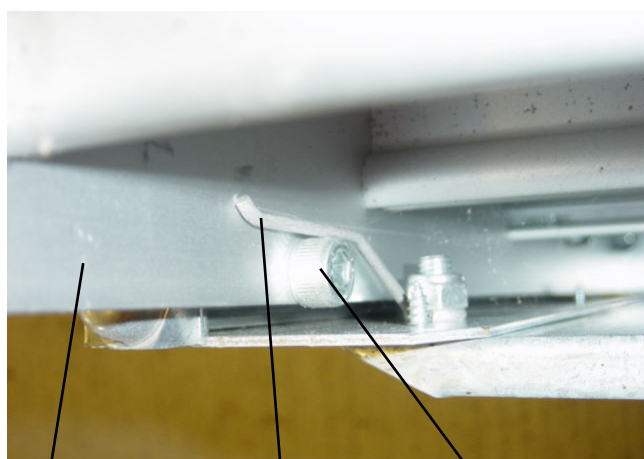
Side Arm Anti-rattle Spring Retaining bolt

ACTION: Check anti-rattle springs on each side at front of case and replace if bent or not catching on side arm.

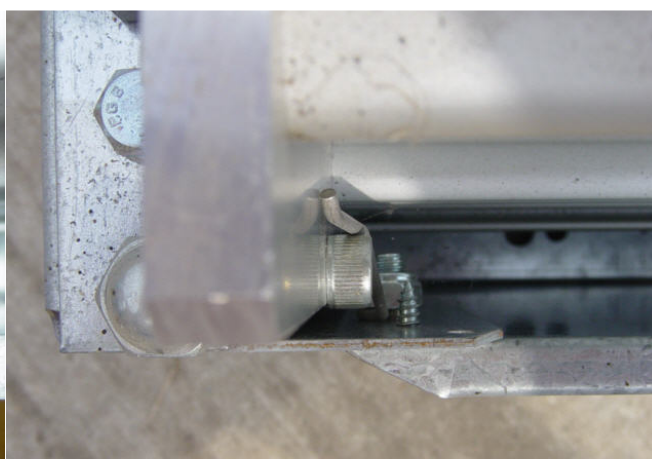
View showing correct alignment of Anti rattle spring.
